Property Inspection Report

SABREEZZ HOME INSPECTION

██████████ Port Washington Drive
Inspection Prepared For: ██████████
Agent: Charmaine. Hatfield -

Date of Inspection: 6/23/2025
Year Built: 0 Size: 3828
Weather:

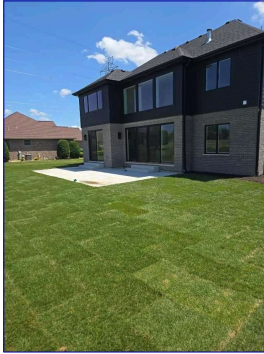
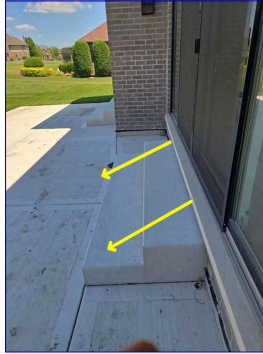
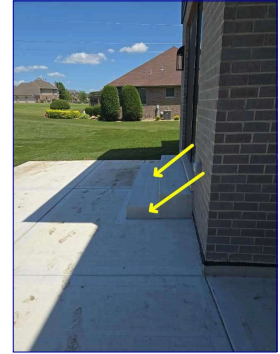
3. Porch

• The porch was missing one or more handrails. This is a safety hazard. A licensed contractor should install proper railing.

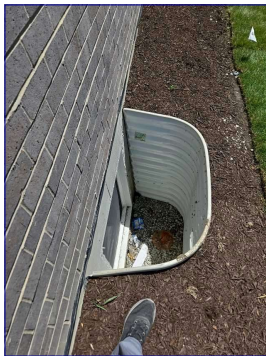
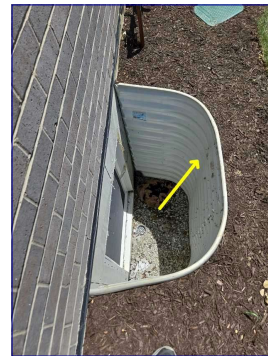
9. Landscape Affecting Foundation

- Recommend window well covers

- Window well covers are missing in one or more locations. Adding window well covers will help prevent moisture and debris from entering the window wells. In addition, an open window well is a falling hazard. Recommend adding window well covers.
- Recommend installing window well ladders, safety concern

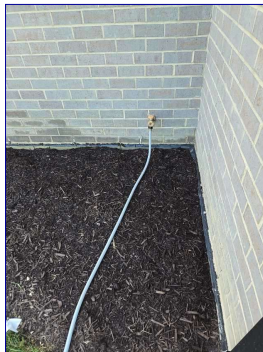
11. Hose Bibs

- Hose bib operational.
- Hoses were attached to the exterior hose bibs. In the wintertime, this will increase the chances of frozen pipes. Recommend removing the hoses during freezing weather.

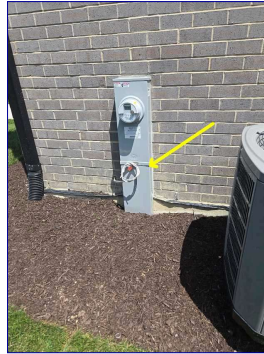
12. Service Entry

- There is an unidentified low voltage wire hanging from the service meter, recommend licensed electrician repair

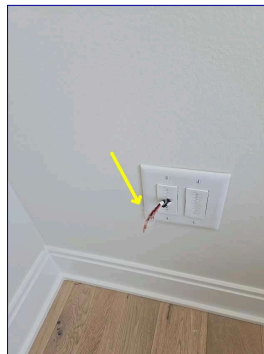
5. Electrical

- Unidentified wires protruding from wall. Recommend repair

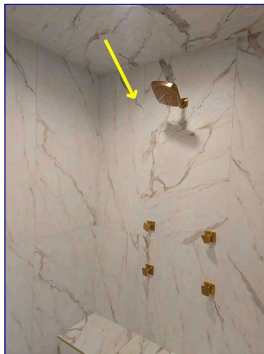
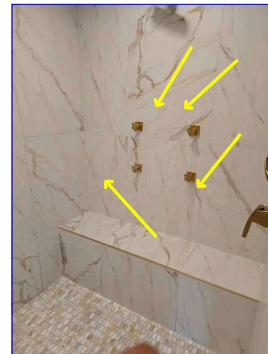
4. Showers

- Showers:
- Faucet leaks: No
 - Pipes leak: Not visible
- Observations:
- Recommend caulking/grouting in the shower and tub area to help prevent damage from water penetration.

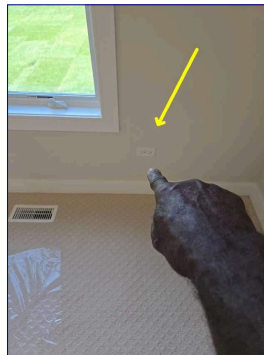
5. Electrical

- Switches operable: Yes
- Receptacles operable: Yes
- Open ground/Reverse polarity: No
- Safety Hazard

- There are loose receptacles present, which is a potential safety concern in bedroom 1. Recommend a licensed electrician repair.

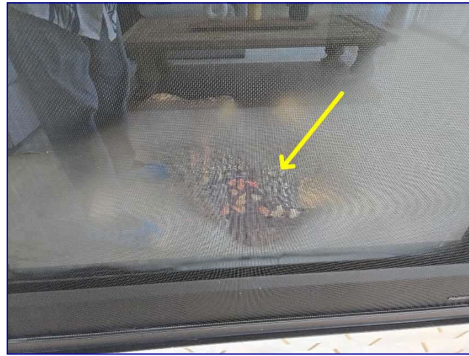
- The fireplace built-in blower fan was not tested as the inspector couldn't evaluate fireplace because it's door couldn't be open by the inspector. The gas shut off valve is located in the basement Recommend a professional fireplace technician evaluation.

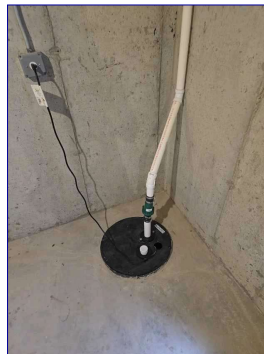
- The floor drain, as seen in the basement, was not tested. Recommend pouring water into the drain periodically to help prevent sewer gases from backing up into the home.
- Please note; the sump pump is one part of the interior and/or exterior drain tile system. The drain is not visible and can not be evaluated as part of the home inspection. Recommend monitoring for moisture in the basement and/or crawlspace, especially after weather or plumbing leaks and related events. Consult a licensed plumber as needed.

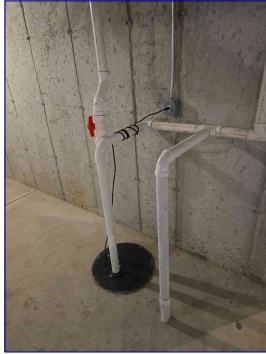
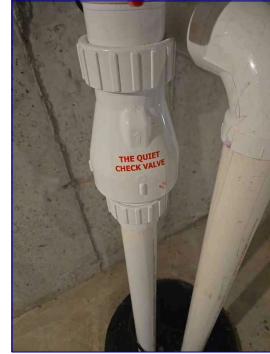
- The sanitary pump was operational when tested. Monitor and consult a licensed plumber as needed.
- The sump pump discharge lines can freeze or become covered with snow/ice and will not discharge water as designed. Recommend installing a product like an ice guard to help prevent freezing and/or flooding. Recommend a professional installation for added safety.

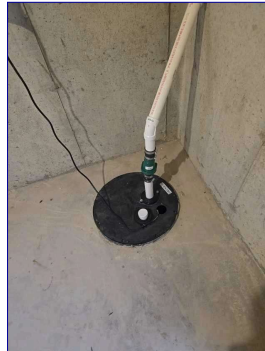
13. Sump Pump

- Please note; the sump pump is one part of the interior and/or exterior drain tile system. The drain is not visible and can not be evaluated as part of the home inspection. Recommend monitoring for moisture in the basement and/or crawlspace, especially after weather or plumbing leaks and related events. Consult a licensed plumber as needed.
