Property Inspection Report

SABREEZZ HOME INSPECTION

● Cloverleaf Road

Date of Inspection: 6/13/2025

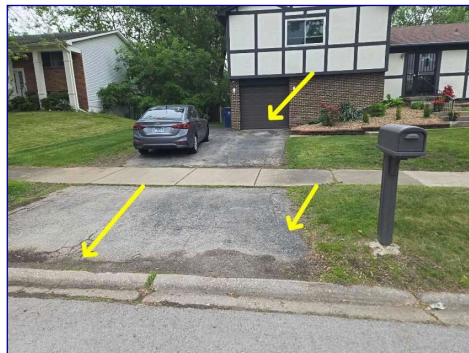
2. Driveway/Parking

- Settling cracks
- Fill cracks and seal

- The driveway/parking material is asphalt. Asphalt should be kept sealed and larger cracks filled to prevent frost damage. Consult a professional contractor as needed.
- The driveway is cracked. Recommend sealing the cracks to help prevent additional damage. Consult a professional contractor as needed.

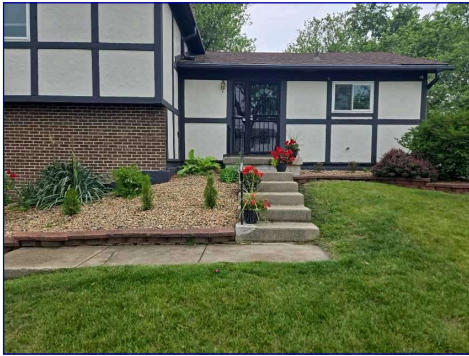
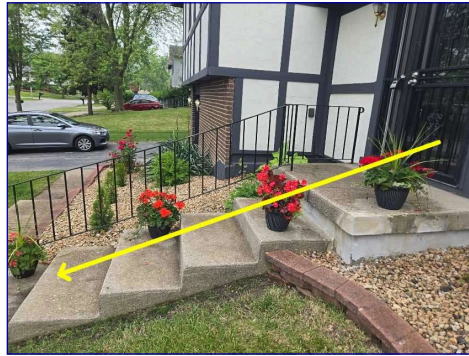
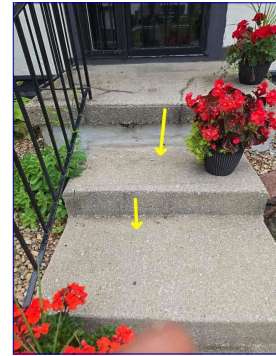
4. Steps/Stoop

- Railing recommended
- Safety hazard

• The exterior stair handrails don't wrap back to the wall/post. This is a safety concern. Recommend a professional contractor install handrails that wrap back to the wall/ post.

• The step risers are uneven on the exterior steps, which may present a trip hazard. Recommend a licensed general contractor repair or replace as needed.

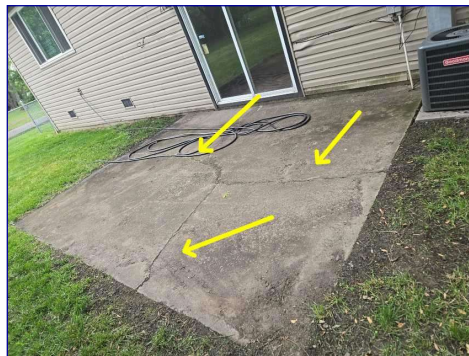
5. Patio

- Settling cracks
- Pitched toward home
- Typical cracks

• The patio has typical cracks. Recommend a professional contractor seal the cracks to help protect the cement from damage.

• The patio had some settlement and is pitched toward the house, which may allow water to drain toward the house and foundation. Recommend a licensed contractor repair.

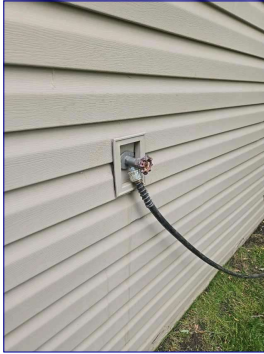
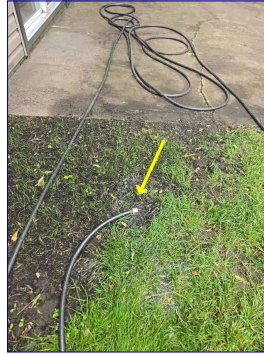
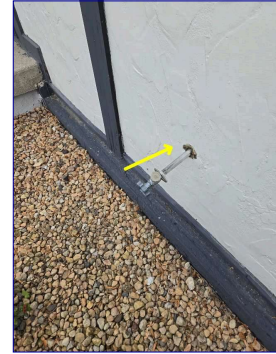
- No anti-siphon valve
- Recommend anti-siphon valve

- Hose bib operational. Rear only. Front bib is not operational and is loose.
- At least one hose bib is not equipped with an anti-siphon device. A possible cross-contamination can occur, which is a potential safety concern. A licensed plumber should install an anti-siphon/vacuum breaker.

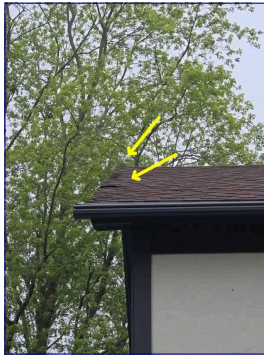
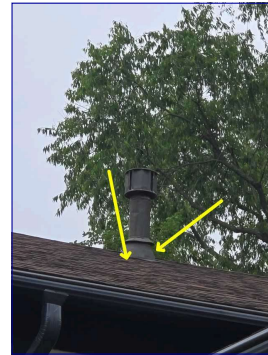
7. Condition of Roof Covering

- Condition:
- Granules missing
 - Moss buildup
 - Nail popping
 - Recommend roofer evaluate
- Observations:
- Some nail popping has occurred on the roof. Recommend a licensed roofer repair.
 - One or more broken/loose tiles exist on the roof. Recommend a licensed roofer to replace the damaged tiles.
 - A number of roof shingles are missing granules. Recommend a licensed roofer evaluate and repair/replace shingles as needed.
 - The roof is considered marginal and requires repair. Recommend a licensed contractor repair all affected areas.
 - Recommend removing moss from the roof to prolong its life

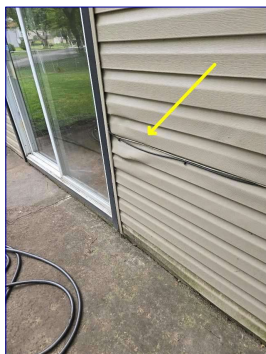
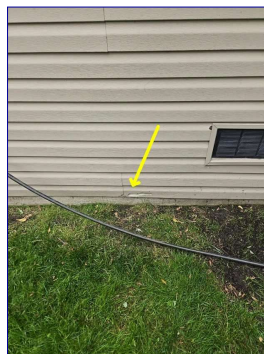
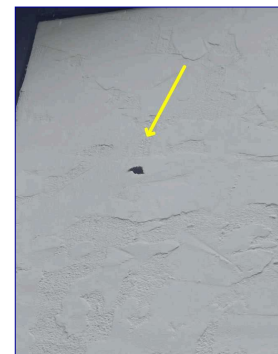
- Typical cracks
- Loose/Missing/Holes in front stucco

- Recommend cleaning all moss build-up on siding to prolong its life
- The siding needs routine repair and painting maintenance. Recommend a licensed contractor to repair and paint the siding.
- The siding had some damage, recommend a licensed contractor repair/replace damaged sections.
- The stucco was in need of routine patching and crack sealing to help prevent moisture from penetrating and causing damage to the stucco. Recommend a licensed professional repair.
- The stucco siding had typical cracking or hole present in one or more areas. Monitor and repair as needed.

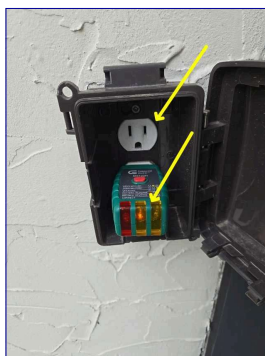
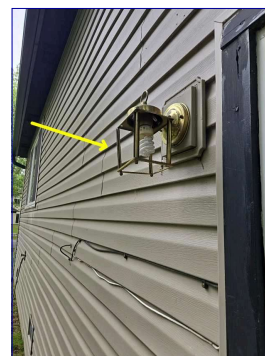
13. Exterior Receptacles

- Exterior receptacles: Yes
- Exterior receptacles, operable: Yes
- **GFCI** present: No
- Recommend GFCI receptacles
- Safety Hazard
- Open ground(s)

- GFCI receptacles are not installed at outdoor locations, which is a safety concern. Recommend a licensed electrician install GFCI receptacles.
- There is open ground on at least one outside receptacle. This is a safety concern. Recommend a licensed electrician repair.
- There are one or more electrical outlets that appear to be worn out and will no longer hold a plug securely and make good electrical contact, this is an electrical hazard. Recommend a licensed electrician replace the outlet.

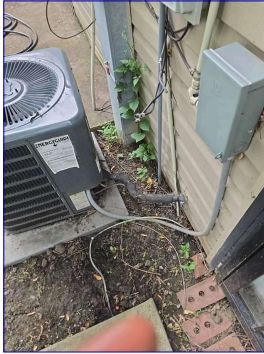
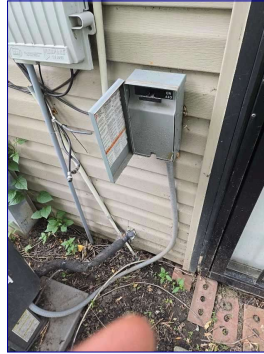
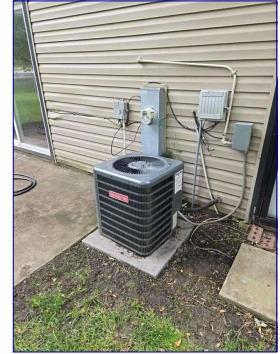
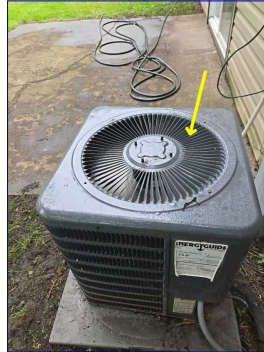
- The condenser was making humbling sounds and recommended hvac contractor evaluation and serviced

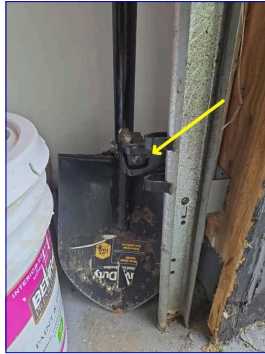
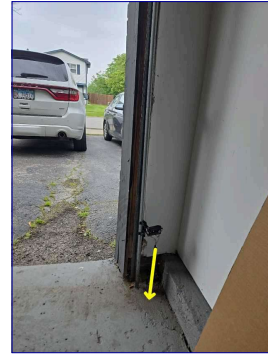
- The garage door electric eyes are too high above the ground, which is a potential safety hazard. Recommend adjusting to 6" from the floor.

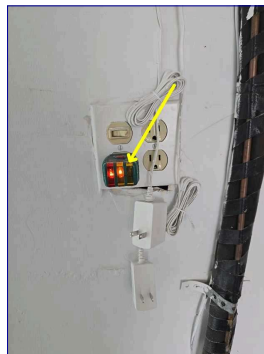
- Reverse polarity: Yes
- Open ground: No
- Safety Hazard

- GFCI receptacles are not installed in the garage. This is a safety concern; however, when the home was built, installing GFCI receptacles was not part of the standard building requirements. Recommend upgrading the GFCI receptacles to current standards for increased safety.
- There are no GFCI's installed in the garage, which is a safety concern. Recommend a licensed electrician install GFCI receptacles.
- Reverse polarity is a potential safety hazard at the garage receptacles. Recommend repair by a licensed electrician.

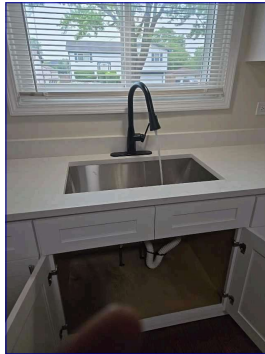
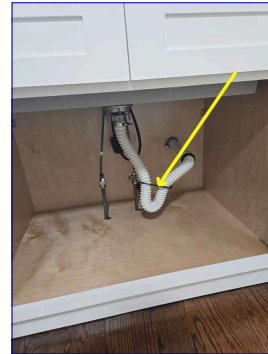
• Flex tubing is being used as part of the drain system in the kitchen. This is a nonprofessional installation of drain piping. Recommend a licensed plumber repair.

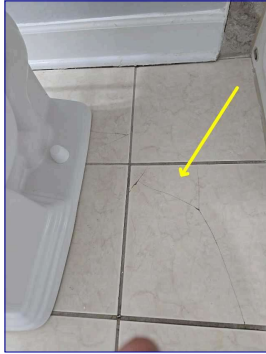
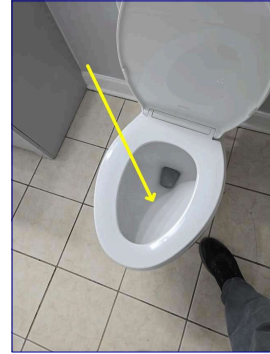
5. Toilet

- Bowl loose: Yes
- Operable: Yes

- The floor tile around the toilet is cracked in bathroom 1. Recommend a qualified contractor evaluate and repair.
- The toilet bowl is loose. Since movement of the toilet will damage the wax ring, recommend replacing the wax ring. While the toilet is removed verify the subfloor is still in good condition. Repair as needed.

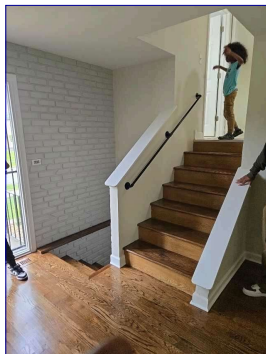
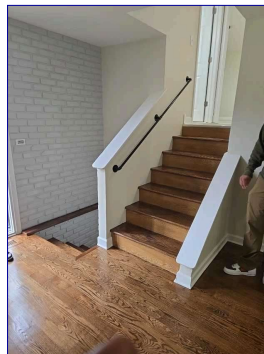
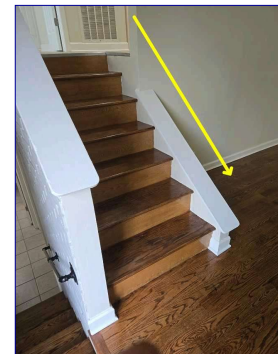
- Stairs condition: Satisfactory
- Handrail: Safety Hazard
- Handrail: Handrail/Railing/Balusters recommended

- The Hallway View
- Balusters are missing on the interior stairs, for additional safety recommend balusters be a maximum of 4" apart - safety concern for small children.
- The handrail doesn't wrap to the wall, which is a safety concern. Recommend installing a hand railing that properly wraps to the wall.
- The bluster on steps leading to the second floor was missing on the interior stairs, which is a safety concern. Recommend a professional contractor install a handrail.

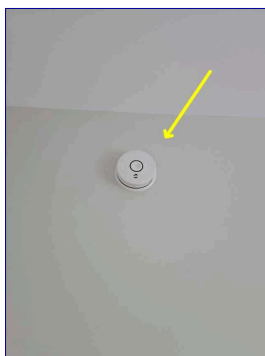
1. Smoke/Carbon Monoxide Detectors

- Smoke detectors are present
- Carbon monoxide detectors are present
- Carbon monoxide detector: Safety Hazard

- At least one smoke alarm was inoperable, which is a safety concern. Recommend repairing or replacing the alarm(s) as needed.
- One or more carbon monoxide alarms were not operational when tested. Recommend repairing or replacing the damaged alarm(s) as needed.
- The life safety and security systems for the commercial building were not tested. Recommend consulting a licensed contractor for an evaluation before closing. Repair as needed.
- Some of the smoke detectors appear to be malfunctioning as the beeping sound doesn't stop at the time of inspection when tested. Recommend evaluation by licensed electrician

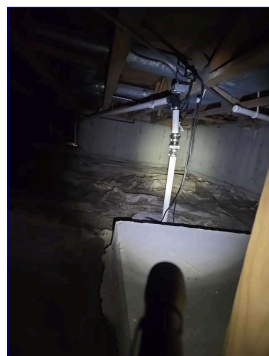
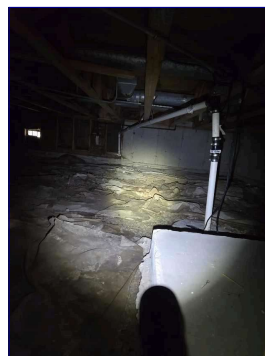
- Sump pump: Yes
- Sump pump not tested
- Standing water: No
- Evidence of moisture damage: No

- The sump pump discharge lines can freeze or become covered with snow/ice and will not discharge water as designed. Recommend installing a product like an ice guard to help prevent freezing and/or flooding. Recommend a professional installation for added safety.
- The crawlspace sump pump was not tested. There is no apparent deficiency. Monitor and consult a licensed plumber as needed.

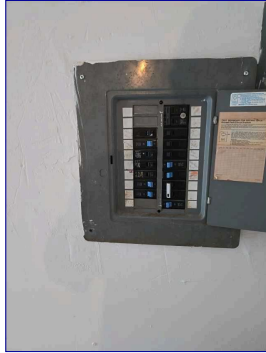
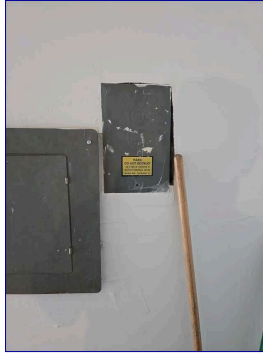
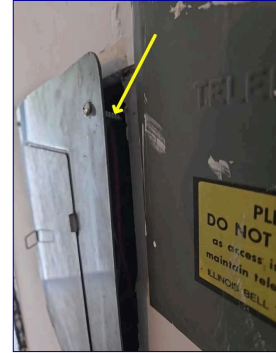
- The main electrical service panel
- The electrical panel cover was not flush with the box recommend a licensed electrician repair.
- Panel door has pointed screws, safety hazard
