Property Inspection Report

SABREEZZ HOME INSPECTION

██████████ Port Washington Drive
Inspection Prepared For: ██████████
Agent: Charmaine. Hatfield -

Date of Inspection: 6/23/2025
Year Built: 0 Size: 3828
Weather:

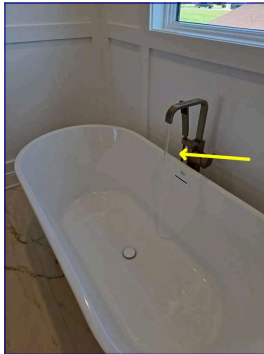
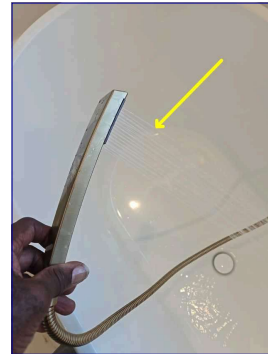
4. Showers

- Showers:
- Faucet leaks: No
 - Pipes leak: Not visible
- Observations:
- Recommend caulking/grouting in the shower and tub area to help prevent damage from water penetration.

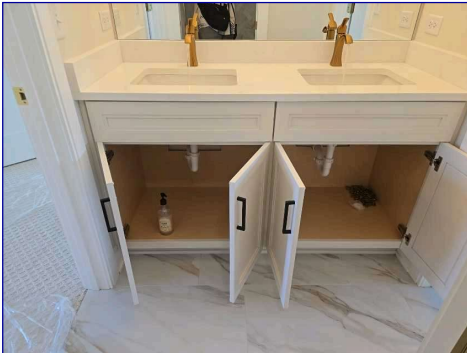
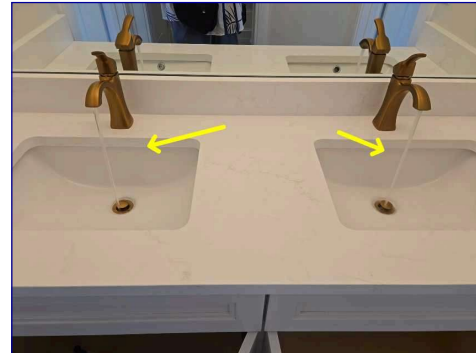
2. Sinks

- Faucet leaks: No
- Pipes leak: No
- Observations:
- The bathroom plumbing view.

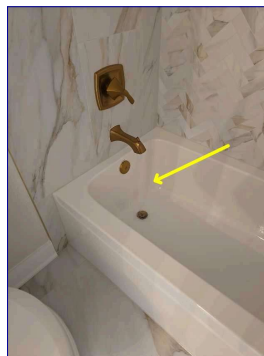
3. Bathtubs

- Faucet leak: No
- Pipes leak: No
- Pipes leak: Not visible

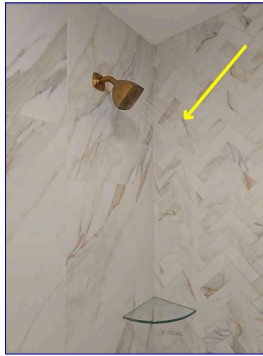
4. Showers

- Showers:
- Faucet leaks: No
 - Pipes leak: Not visible

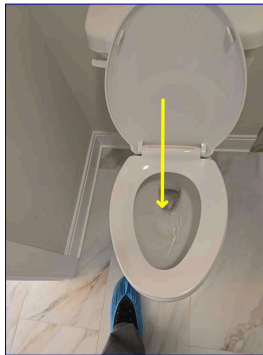
5. Toilet

- Bowl loose: No
- Operable: Yes

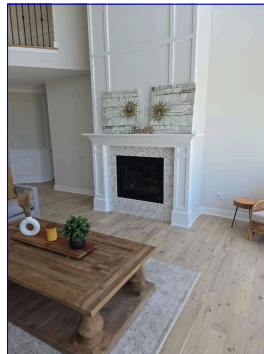
- Metal insert

- The fireplace built-in blower fan was not tested as the inspector couldn't evaluate fireplace because it's door couldn't be open by the inspector. The gas shut off valve is located in the basement Recommend a professional fireplace technician evaluation.

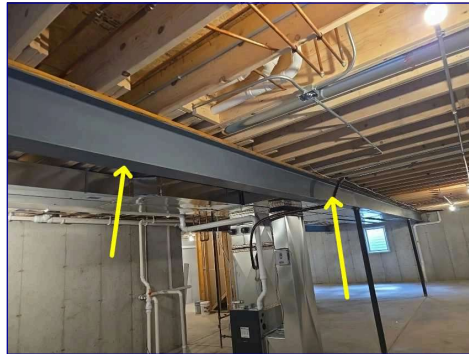
Materials:
• Steel

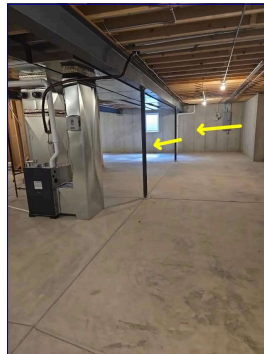
Materials:
• Steel

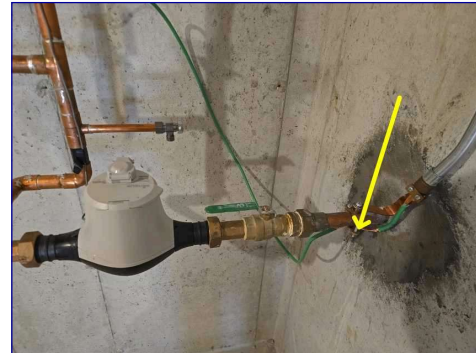
2. Water Entry Piping

- The main water shutoff valve

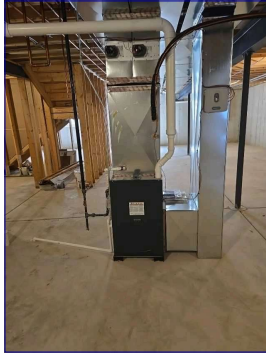
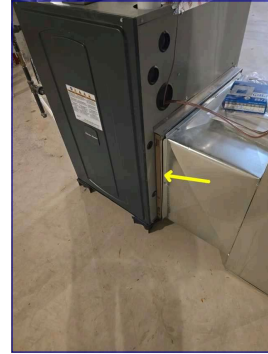
- Brand:
- Brand: American Standard
- Observations:
- The furnace area

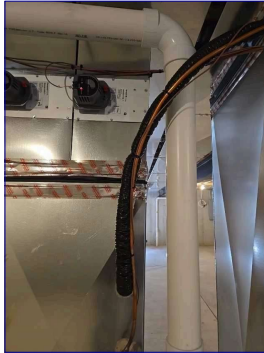
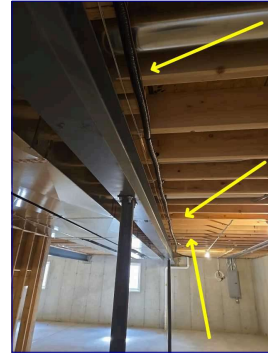
- The evaporator coil cabinet
