Property Inspection Report

SABREEZZ HOME INSPECTION

● Cloverleaf Road

Date of Inspection: 6/13/2025

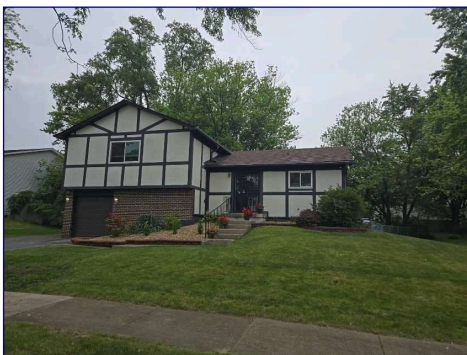
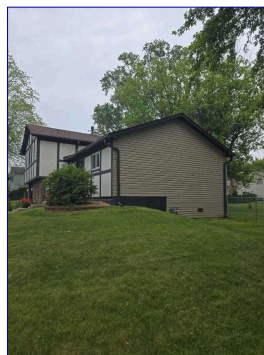
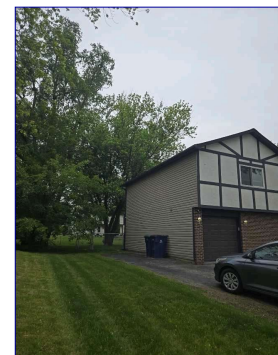
- The front of the house
- The side of the house
- The back of the house

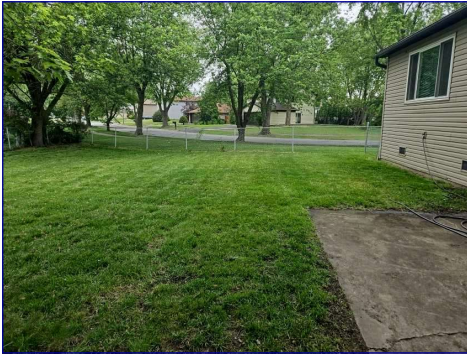
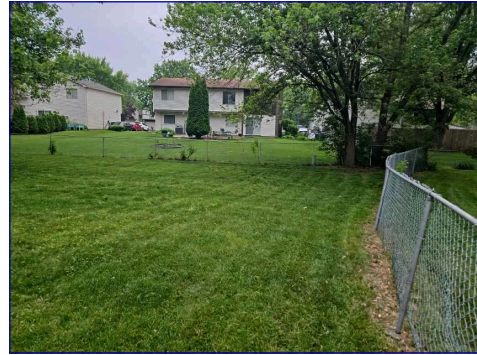
- The Fence View

• The fence is excluded from the home inspection. All comments are made for courtesy purposes only.

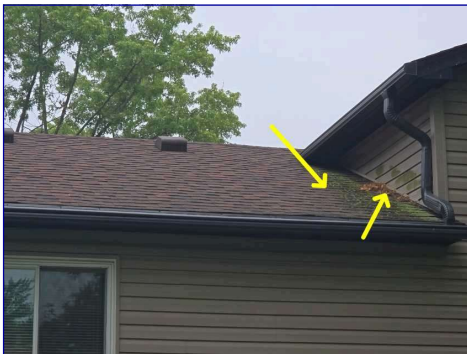
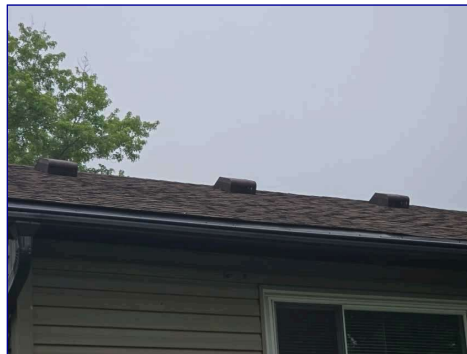
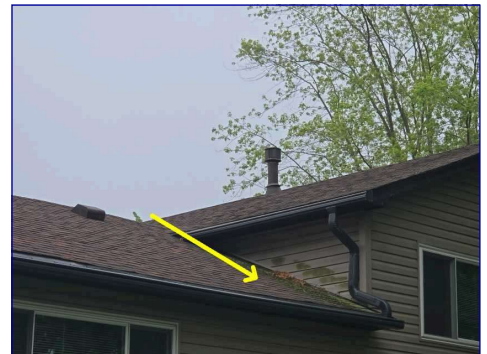
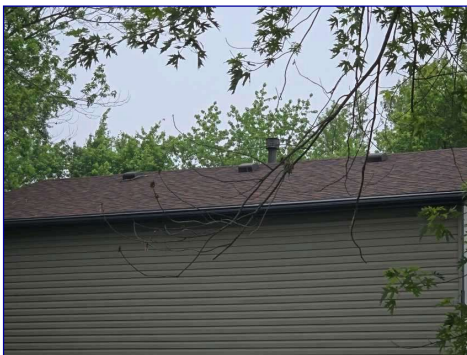
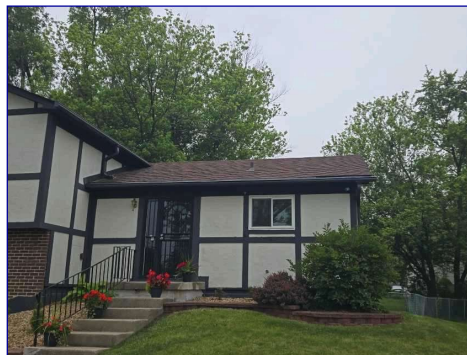
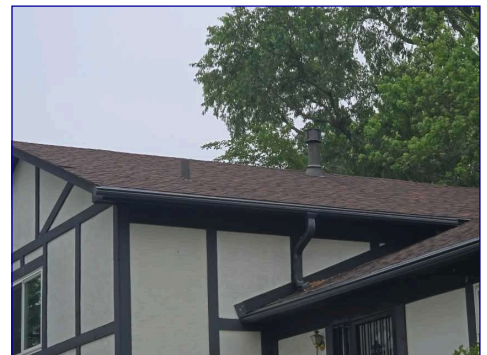
1. Roof View

Page 13 Item: 7	Condition of Roof Covering	<ul style="list-style-type: none"> • One or more broken/loose tiles exist on the roof. Recommend a licensed roofer to replace the damaged tiles. • A number of roof shingles are missing granules. Recommend a licensed roofer evaluate and repair/replace shingles as needed. • The roof is considered marginal and requires repair. Recommend a licensed contractor repair all affected areas. • Recommend removing moss from the roof to prolong its life
-----------------	----------------------------	--

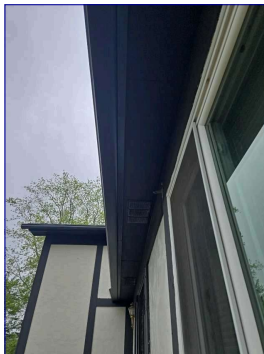
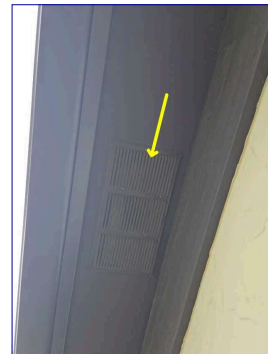
- The Soffit Vent
- The Roof Vent

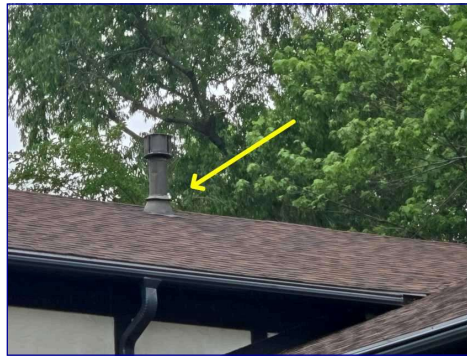
- Flue: Metal
- Observations:
- The Chimney Chase

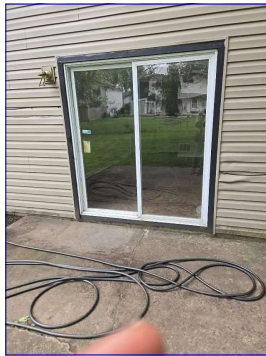
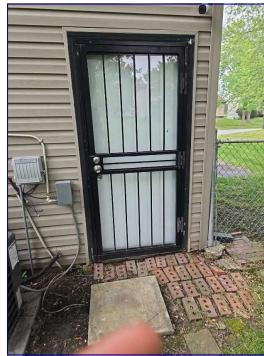
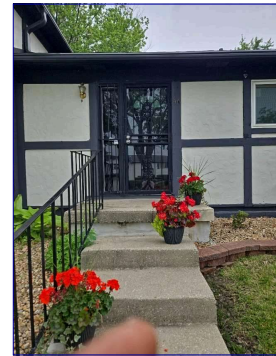
- The Main Entrance Door
- The Patio Door
- The Rear Door

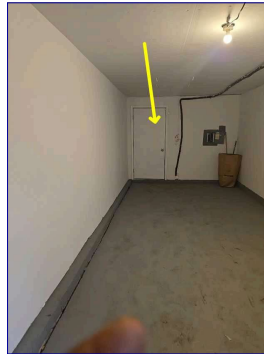
- Garage exterior service door view.

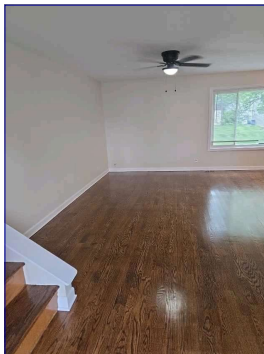
- The Living Room View

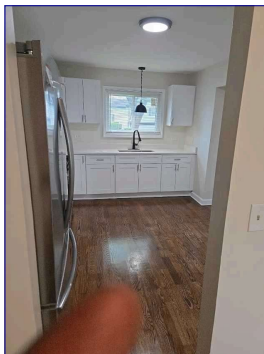
1. Kitchen Photo

Photos
• The Kitchen View

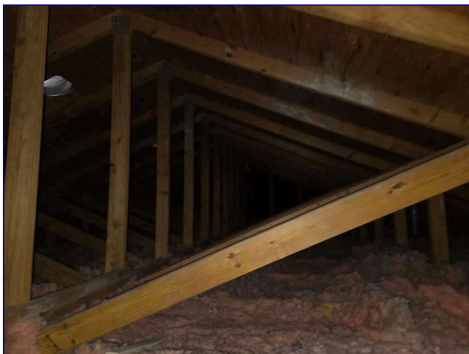
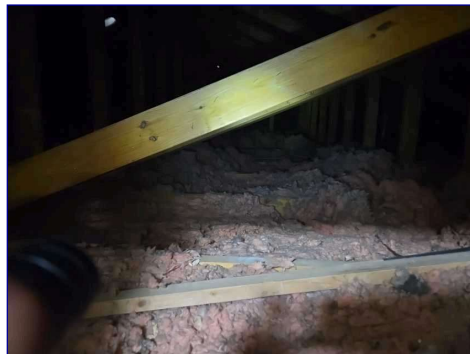
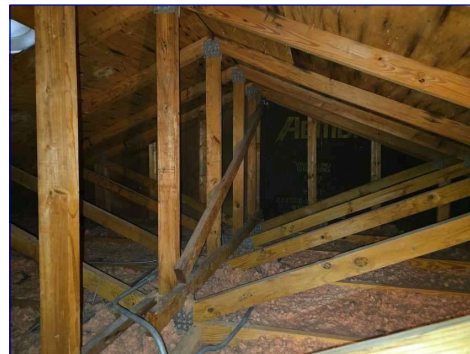
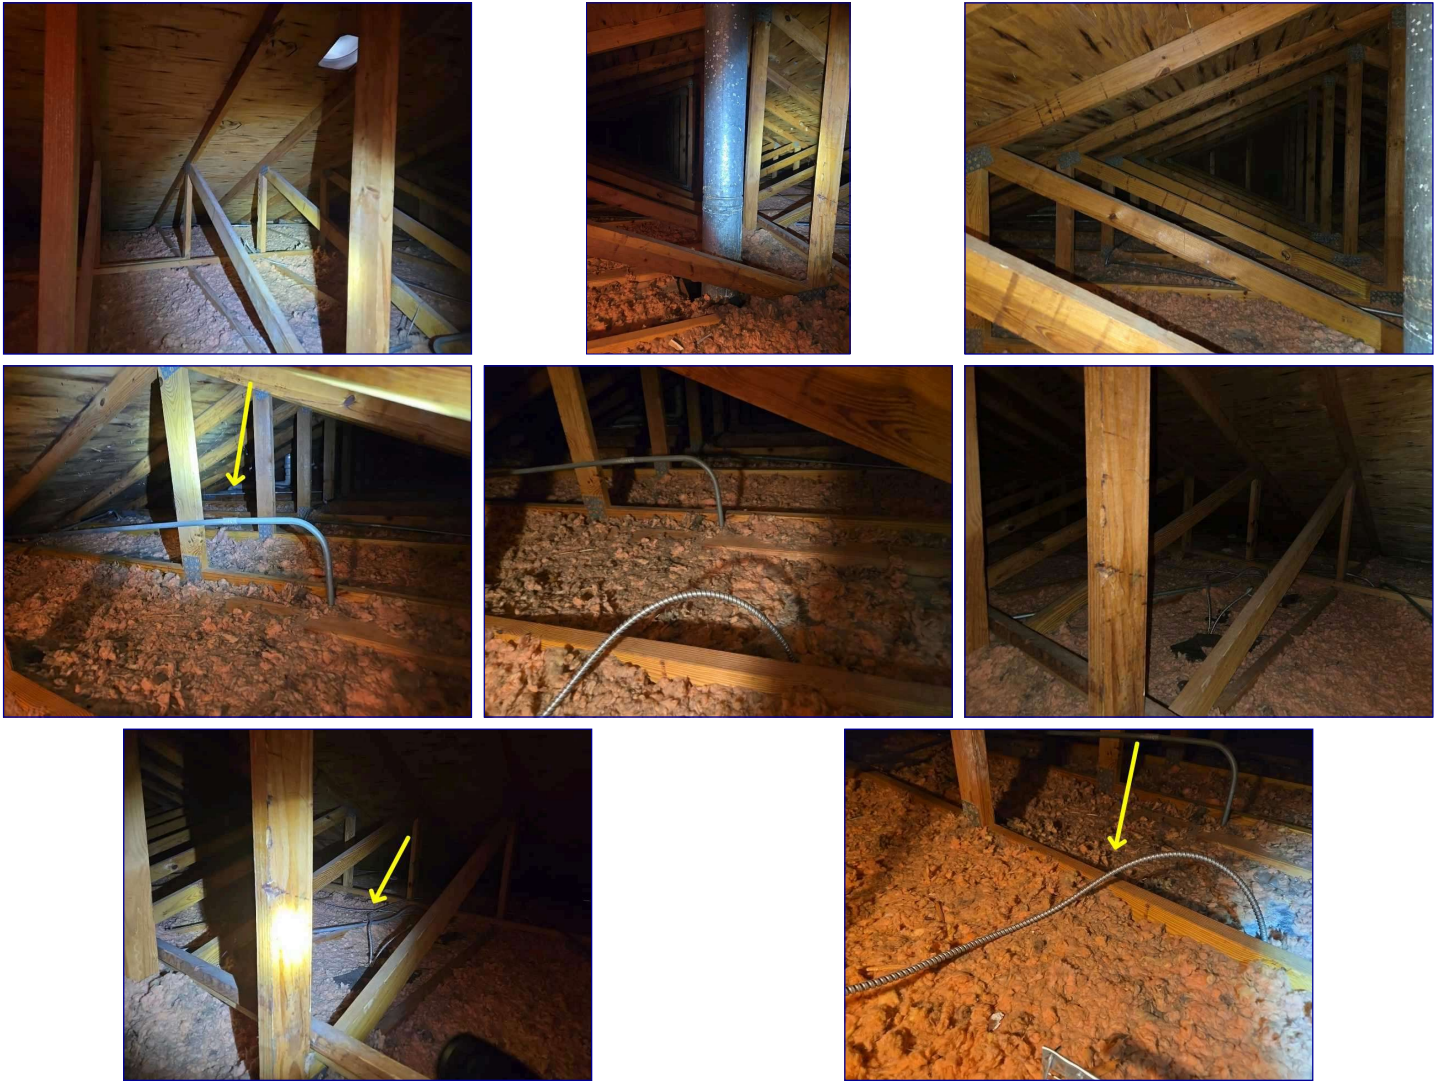
- The Attic View

- The attic insulation is not sufficient for current building standards. Recommend a licensed professional add additional insulation.
- Insulation is displaced in the attic. Recommend a professional contractor re-distribute the insulation.

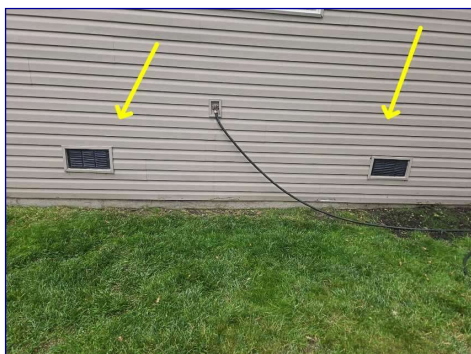
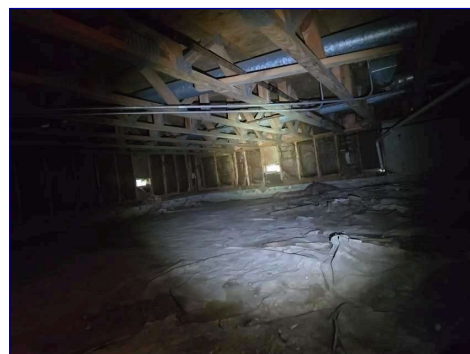
- Observations:
- The crawl space

- All are not visible. Some walls are covered with insulation and not visible. Recommend monitoring for active water intrusion or evaluation by masonry contractor.

- Some of the foundation walls were covered with insulation and were not visible. It is always possible that hidden damage may exist in non-visible areas. Consult a licensed contractor as needed.

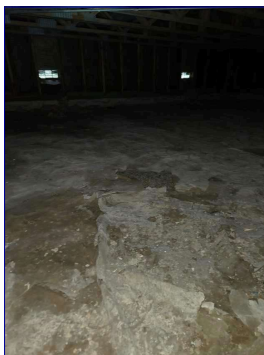
- The crawl space floor
- There was no evidence of moisture intrusion into the crawlspace at the time of inspection. Recommend monitoring and evaluation by contractor if needed.

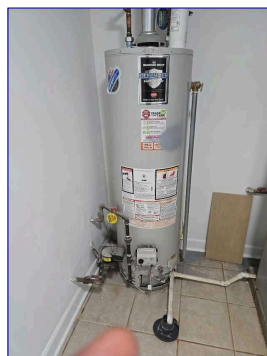
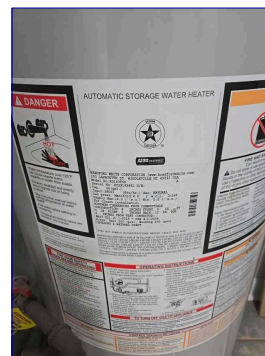
- The Water Heater Area

- The average life expectancy for a water heater is 8-12 years. Recommend budgeting for replacement.
